Plumbing issues

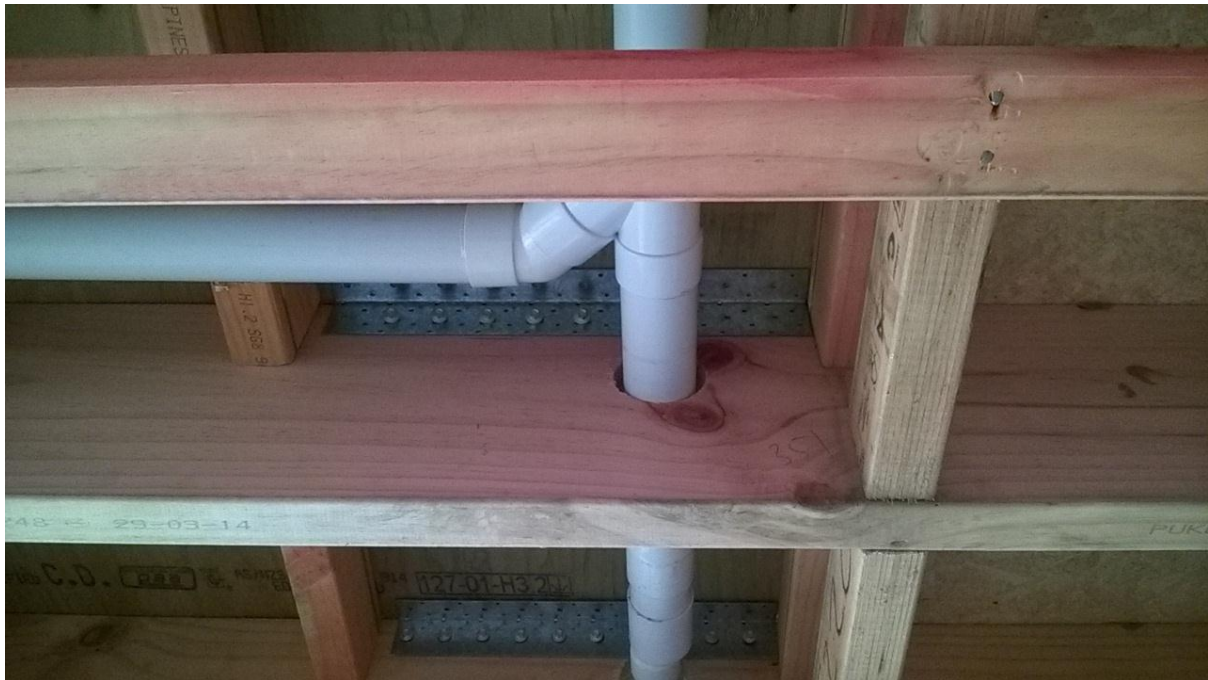
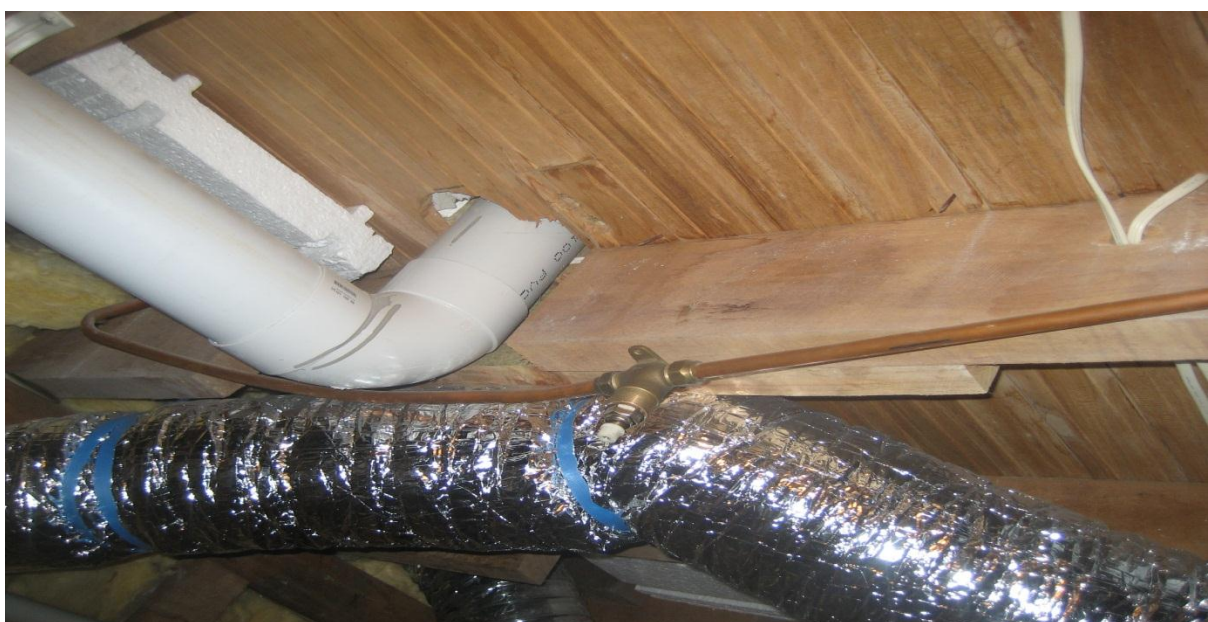
We continue to see a significant number of structural problems caused by the installation of plumbing pipes. By far the greatest problem is the drilling of holes or the cutting of notches into floor joists or top and bottom plates.

NZS3604:2011 states that any hole drilled in a joist other than a cantilevered joist be:

- Within the middle third of the depth of the joist; and
- Not more than 3 times the depth of the joist from the face of the support

The maximum diameter of a hole is $D \div 5$ (joist depth divided by 5) or 32mm, whichever is less

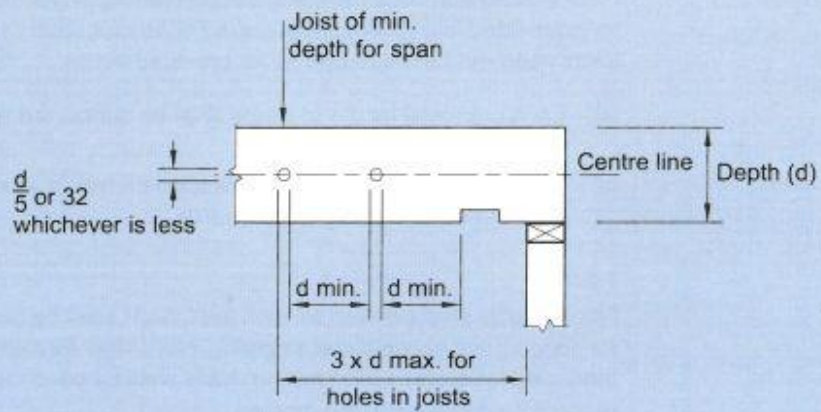
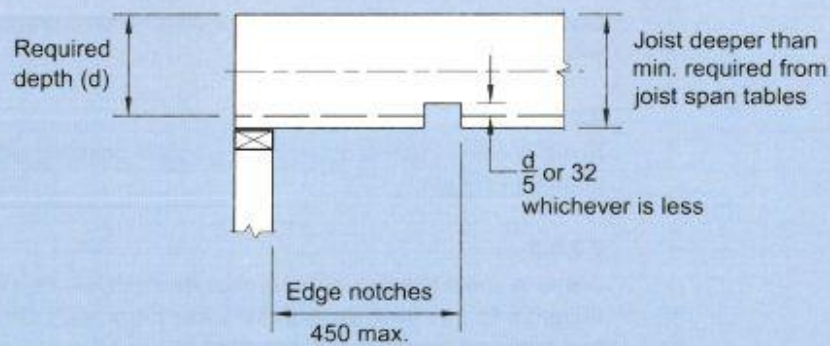
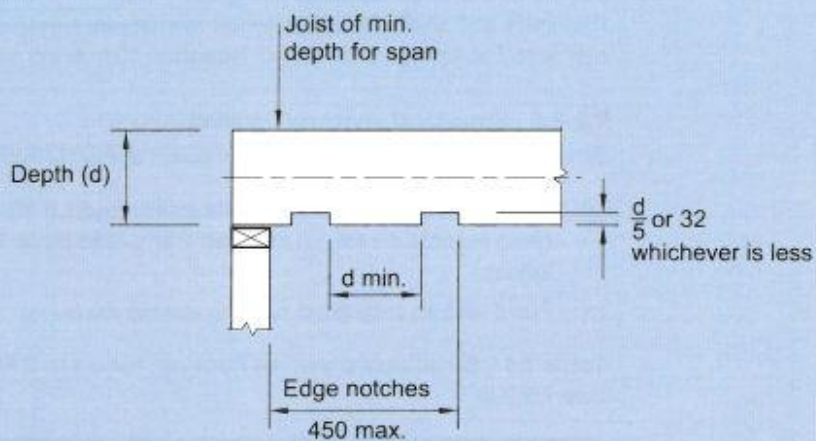
Refer to NZS3604:2011, figure 7.8 attached

(A) (see 7.1.7.1)

(B) (see 7.1.7.2)

(C) (see 7.1.7.3)

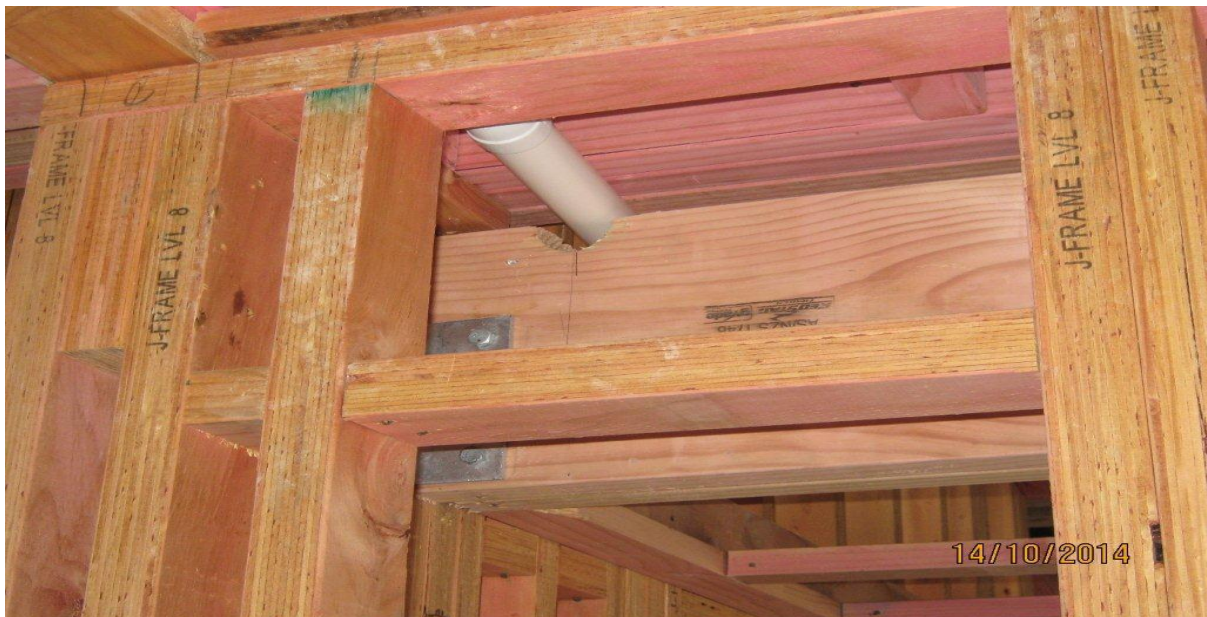
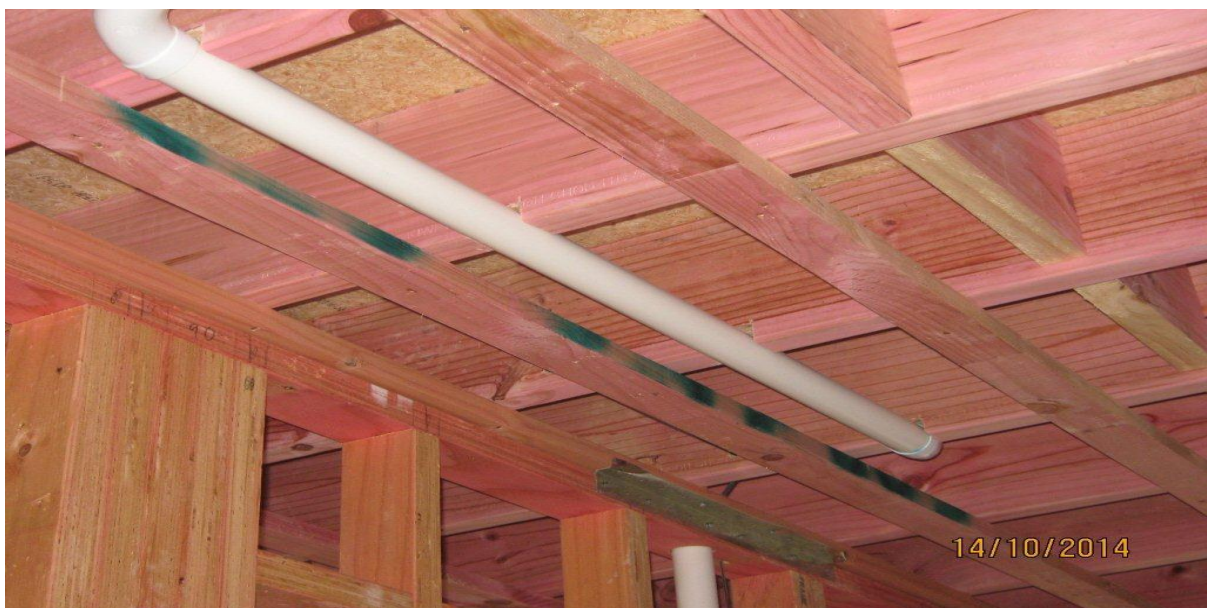
Notches in floor joists other than those in cantilevered joists shall not be more than 450mm from the face of the support; except that notches that do not reduce the effective depth of a joist are permitted in any position.

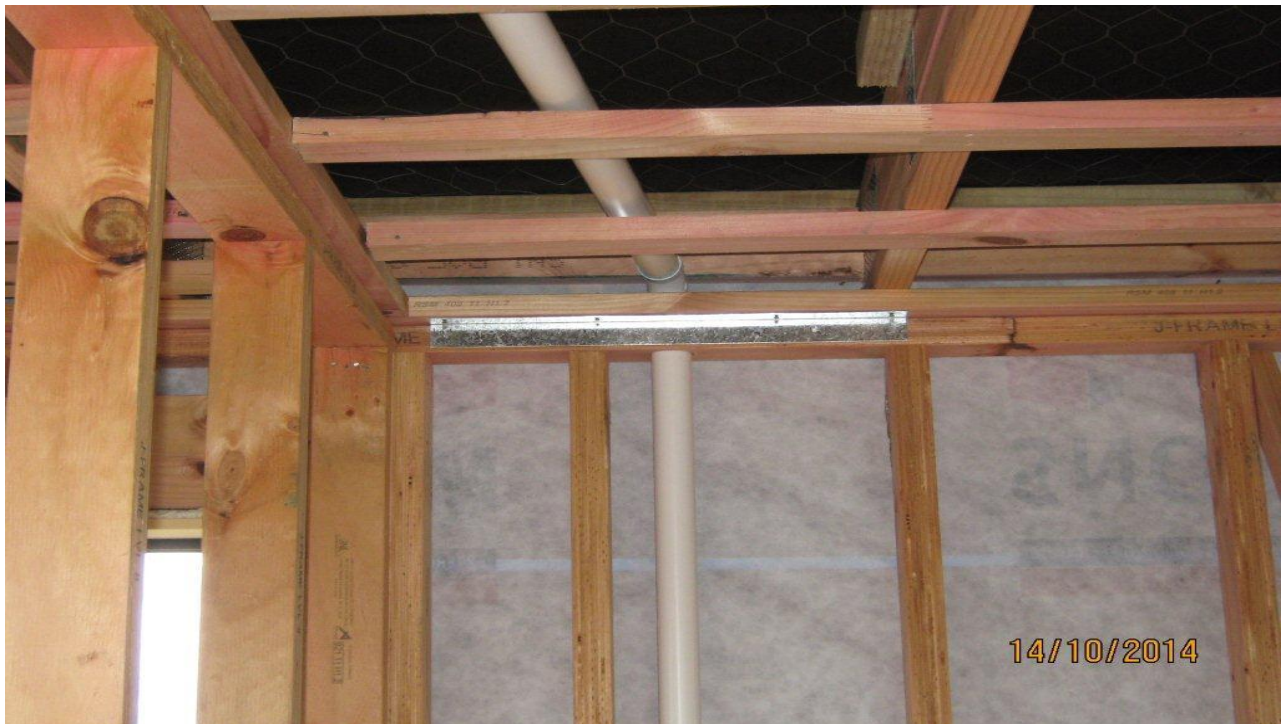
NB there are some proprietary products available on the market; the above method is similar to figure 8.20 below but is not correct.

Where the size of the hole or notch exceeds these dimensions, the plates must be strengthened.
